Manhole Inspection Summary

Manhole # S15AA_035MH

Insp Date: **5/11/09 9:19 AM**

Location Address: **940 MOSHER ST** Cross Street: **CLAYMONT AVE**

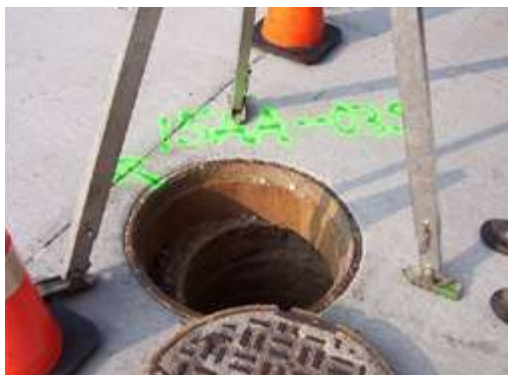
Location View

FRAME OFFSET

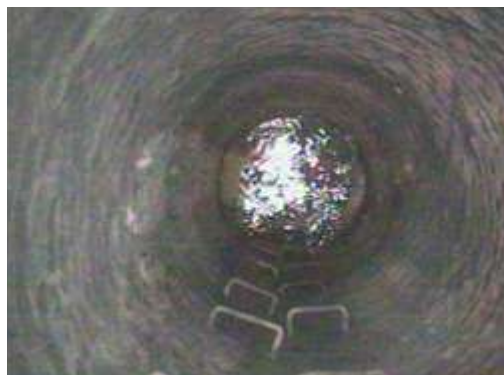
Top View

MANHOLE WAS TOO DEEP AND WASN'T SAFE TO DIVE. GAS METER WENT OFF HALF WAY DOWN.

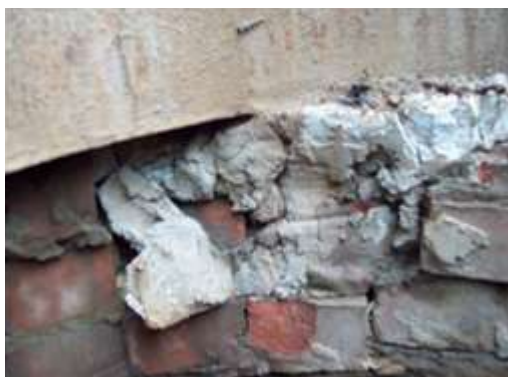
Defect 3

Chimney / Frame Adjustment ☒ Exists Material: **Brick and Concrete** ☐ Parged Height: **3** (in.)
Condition: ☐ Sound ☒ **Cracked** ☐ Root Intrusion ☐ Loose Brick ☐ Deteriorated
Infiltration: ☒ None ☐ Joint ☐ Cracks ☐ Mortar ☐ Roots ☐ Wall

CRACKED CHIMNEY

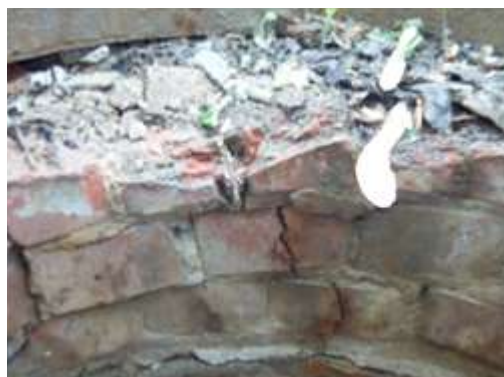
Defect 2

Corbel Material: **Brick** ☐ Parged Type: **Concentric/Eccentric**
Condition: ☐ Sound ☒ **Cracked** ☐ Root Intrusion ☐ Loose Brick ☐ Deteriorated
Infiltration: ☒ None ☐ Joint ☐ Cracks ☐ Mortar ☐ Roots ☐ Wall

CRACKED CORBEL

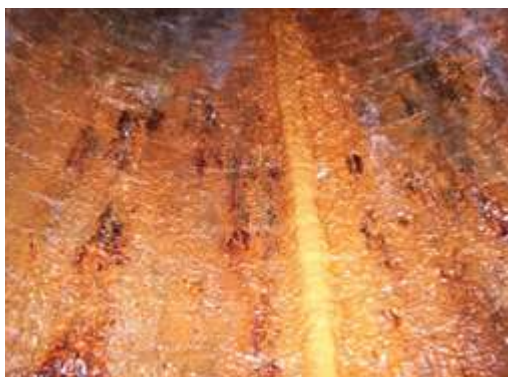
Defect 1

Barrel Material: **Brick** ☐ Parged
Shape: **Circular** Diameter: **46** (in.) Length: (in.)
Condition: ☒ Sound ☐ Cracked ☐ Root Intrusion ☐ Loose Brick ☐ Deteriorated
Infiltration: ☐ None ☐ Joint ☐ Cracks ☐ Mortar ☐ Roots ☒ **Wall**

INFILTRATION WEEPER - BARREL

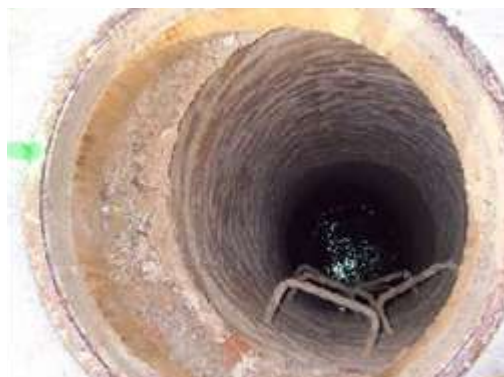
Defect 4

Frame Offset: **3** (in.) Condition: ☒ Sound ☐ Cracked ☐ Leaks

frame offset

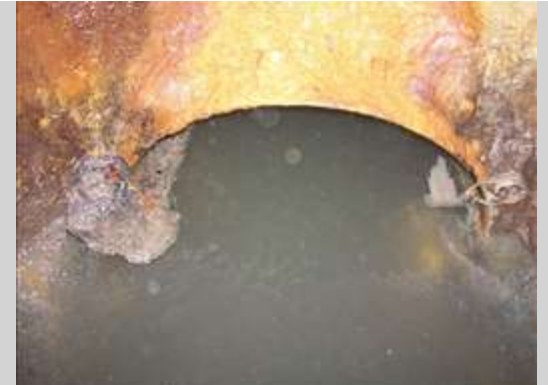
12 O'Clock Outflow

33 in. Circular Gravity Sewer
Pipe Out @ 12 O'Clock

Pipe Height: (in.) Direct
Pipe Material: **Clay** ☐ Pipe Lined
Invert Depth: **37.45** (ft.) Flow Characteristics: **Fast**
Deposits: ☐ None ☐ Mud ☐ Sludge ☐ Debris ☒ Grease
Silt Depth: **4** (in.) Deposits Extent: **Light**
Infiltration: **None** Pipe Seal Cond: **Sound**

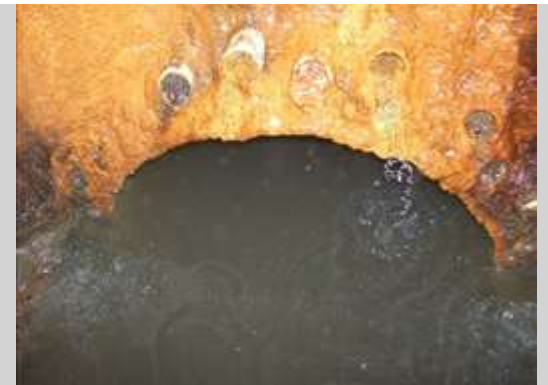
6 O'Clock Inflow

33 in. Circular Gravity Sewer
Pipe In @ 6 O'Clock

Pipe Height: (in.) Direct
Pipe Material: **Clay** ☐ Pipe Lined
Invert Depth: **36.93** (ft.) Flow Characteristics: **Fast**
Deposits: ☒ None ☐ Mud ☐ Sludge ☐ Debris ☐ Grease
Silt Depth: (in.) Deposits Extent:
Infiltration: **Evidence** Pipe Seal Cond: **Sound**
